When it **Breaks**, it Pours

Large diameter pipeline breaks - planning, maintenance, and condition assessment activities that can help prevent these high profile pipeline failures.

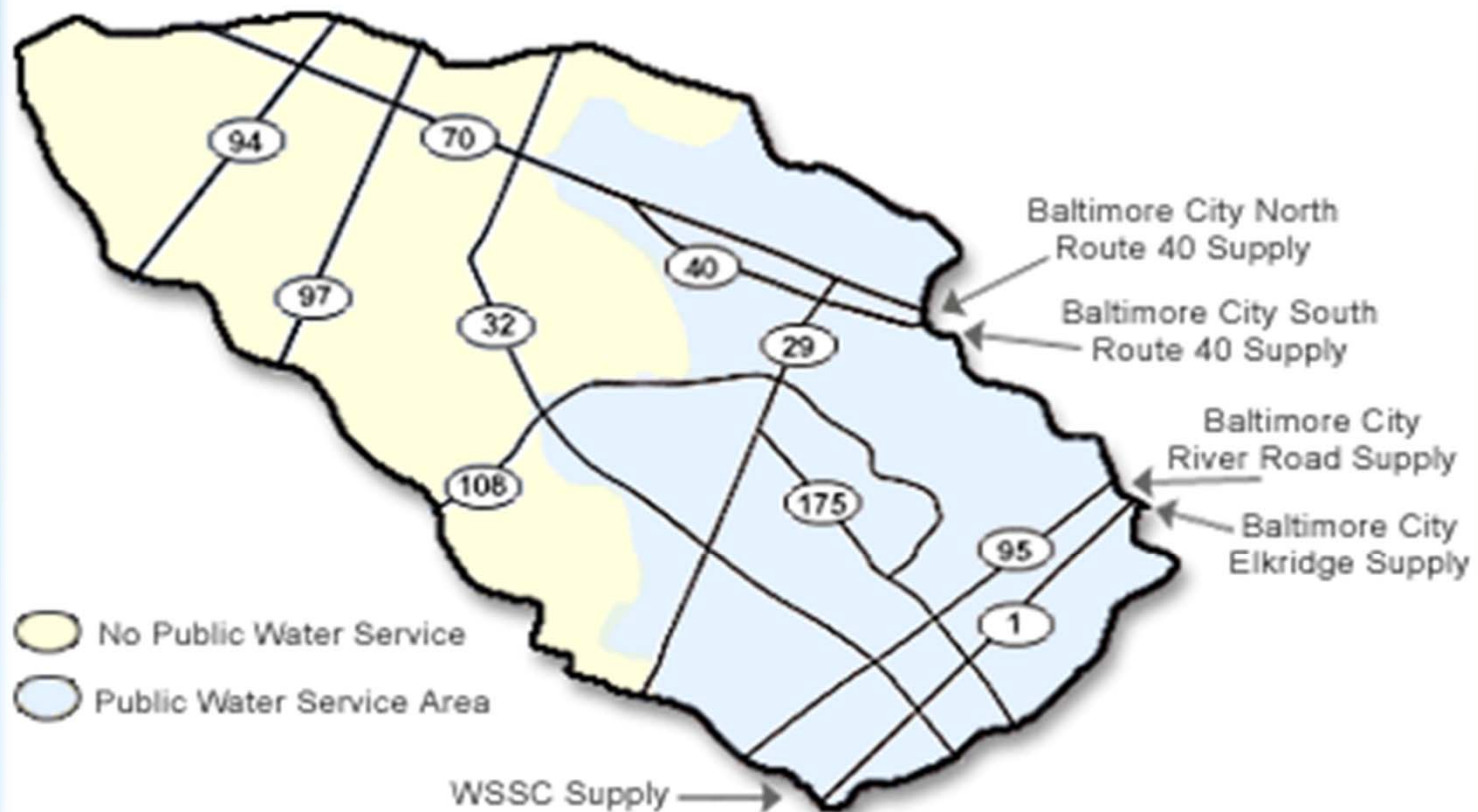
Howard County Public Water Supply Sources

- Today, Howard County's population is about 300,000 people.
- The current water distribution system consists of 1000 miles of pipe, both large and small diameter.
- 95% of Howard County's water is provided from Baltimore City through 20 miles of large diameter PCCP transmission mains.

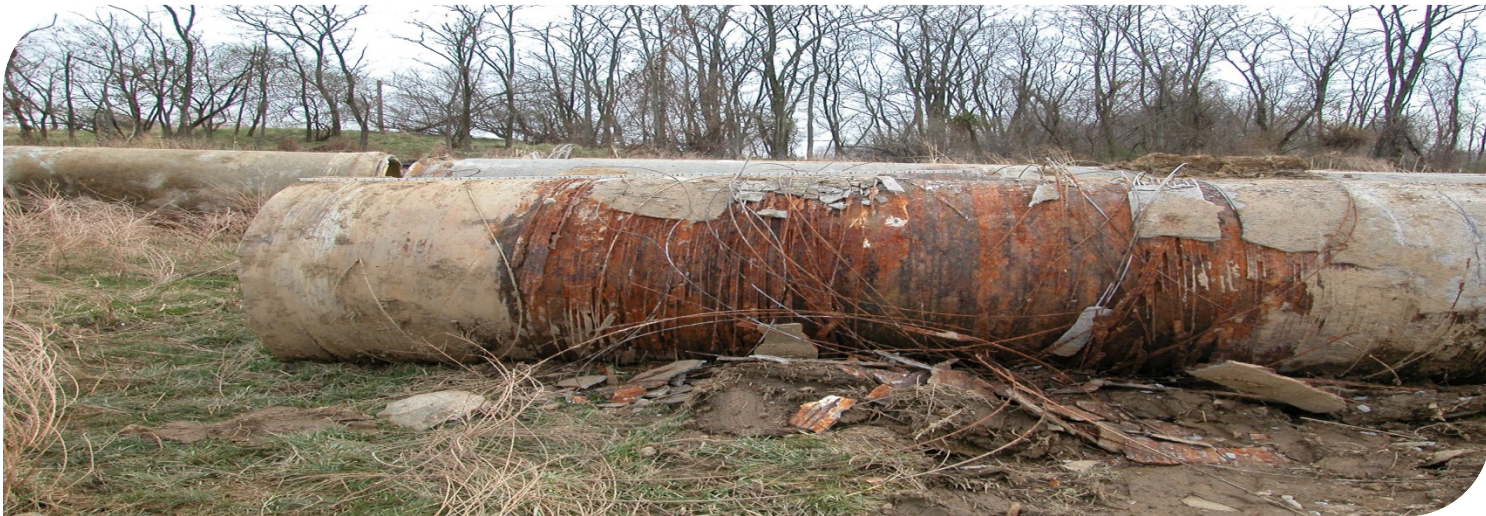
- In 1979, Howard County experienced its first catastrophic failure of Prestressed Concrete Cylinder Pipe.

- Over the next 11 Years, two leaks and five more catastrophic failures were experienced in the 36 inch Elkridge Transmission Main.
- In 1990, a consultant was hired to investigate the failures and it was concluded that the failures were a result of poor quality mortar coating, defective prestressed wires, and incorrect grade steel cylinders.

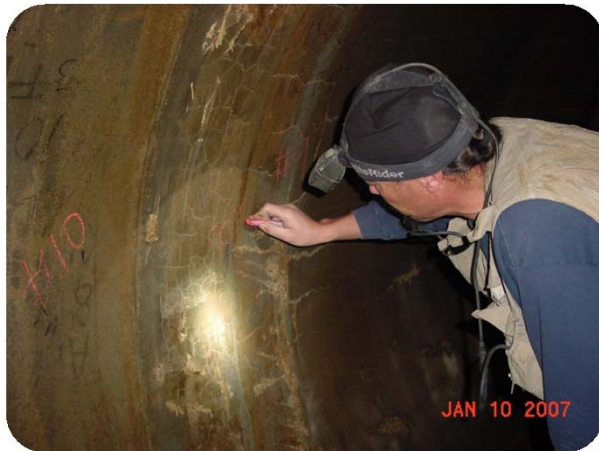
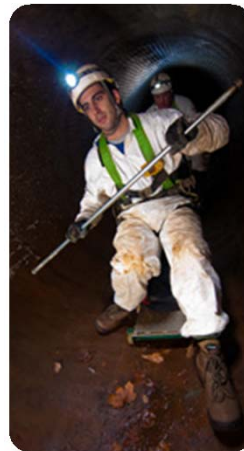
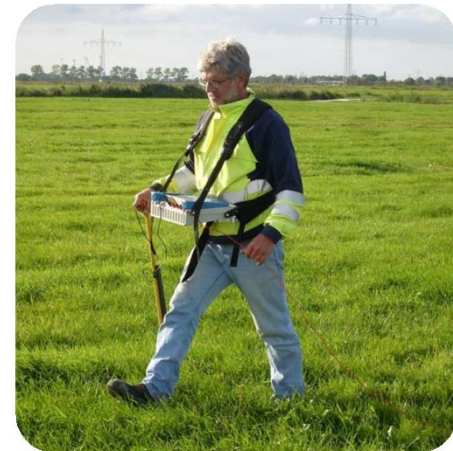
- Howard County would systematically shutdown the mains to perform visual analysis, sounding tests, and corrosion evaluations.

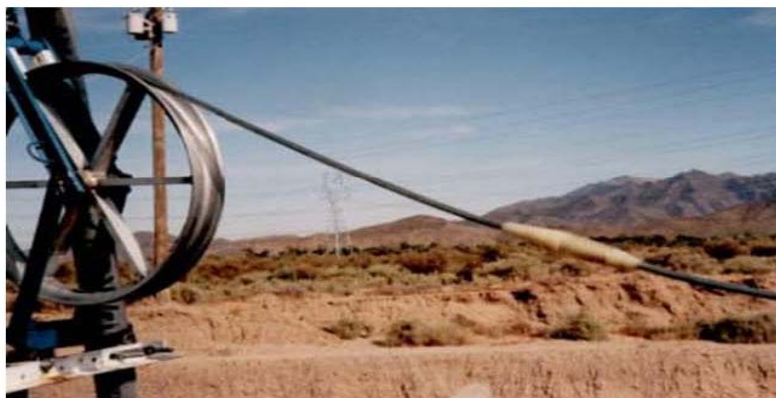
- In 1999, Howard County became aware of the work Pure Technologies was doing with Hydrophones and entered into a contract with Pure to monitor portions of Precast Concrete Cylinder Pipe.

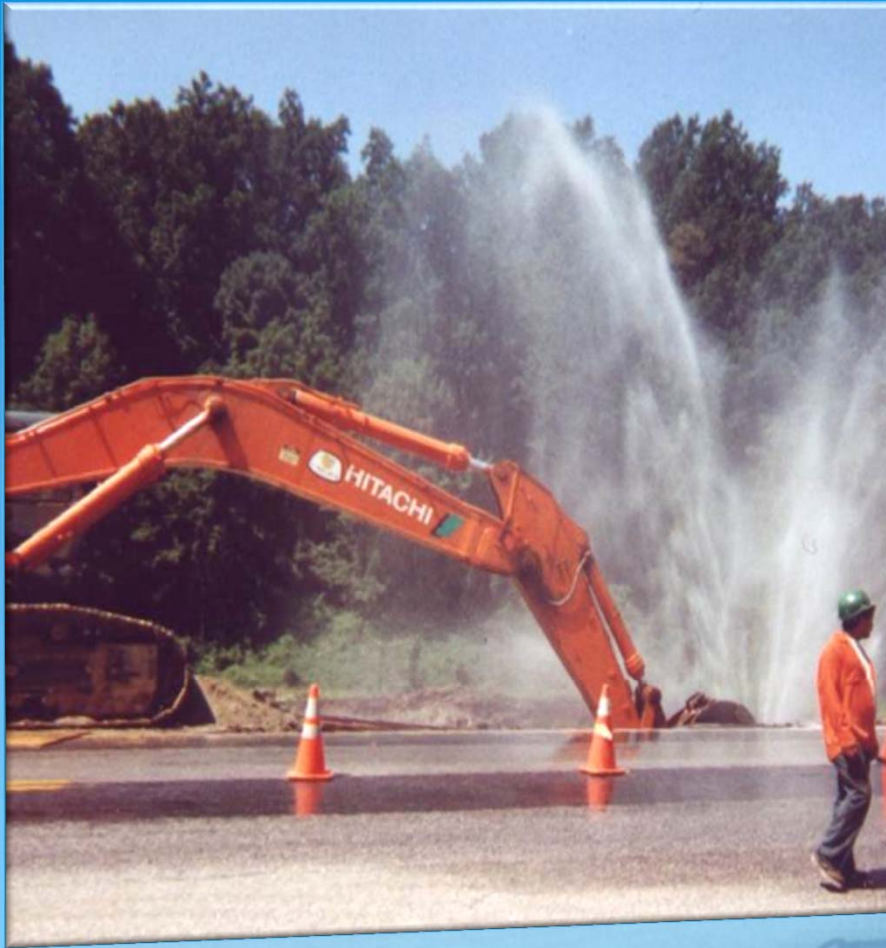
- The arrays would be installed in one mile sections of the main for a 3-month period then moved to the next location.
- In the summer of 2000, Pure Technologies, informed us of a “very active” pipe section located in a portion of main that they were monitoring.

Pure pinpointed the location and the Bureau of Utilities mobilized to excavate the pipe section.

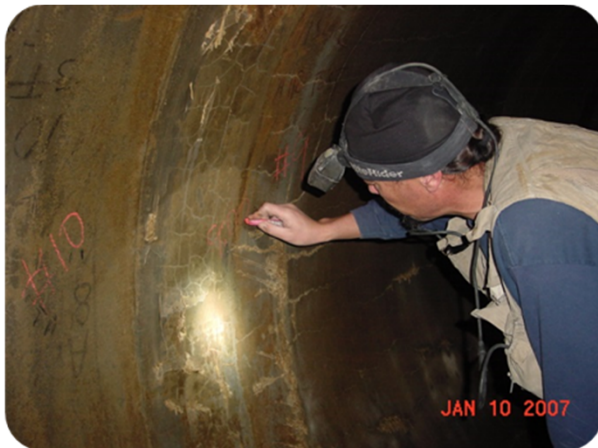
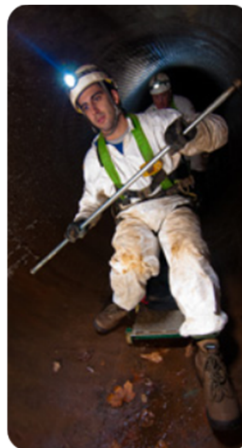
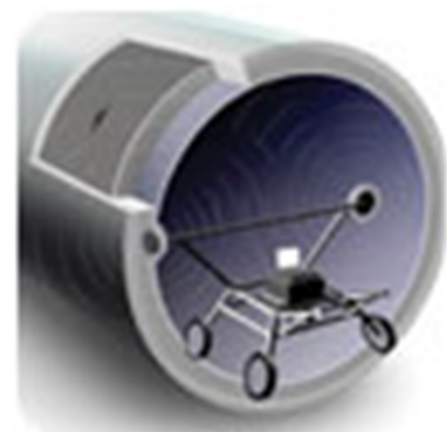
Phase I - Visual analysis, sounding tests, and Electromagnetic Inspections.

- Establishes a baseline of the current condition of transmission main.

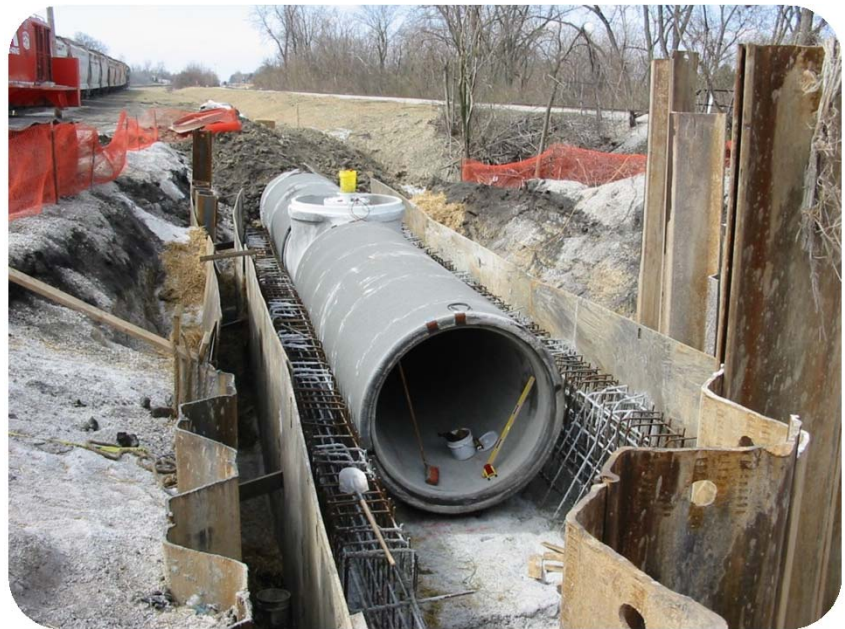
Phase III - Address pipes damaged beyond a minimum threshold, repair using carbon fiber reinforcement or replace.

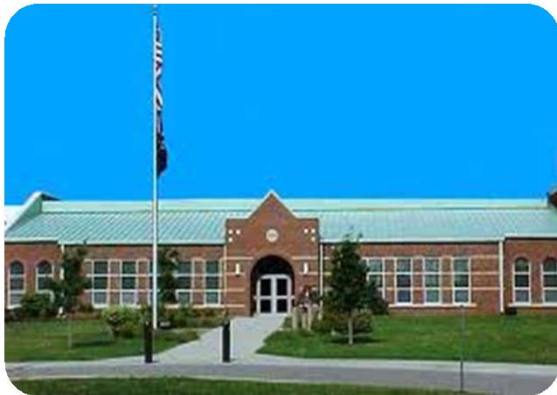
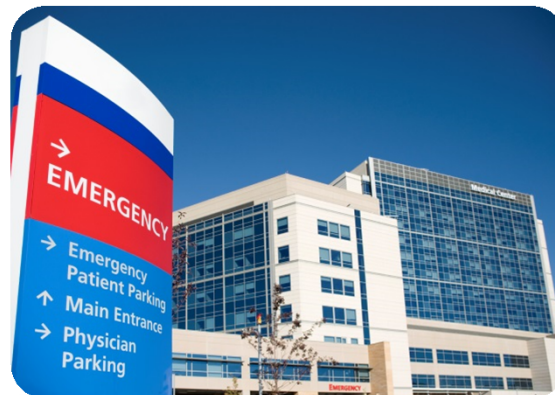
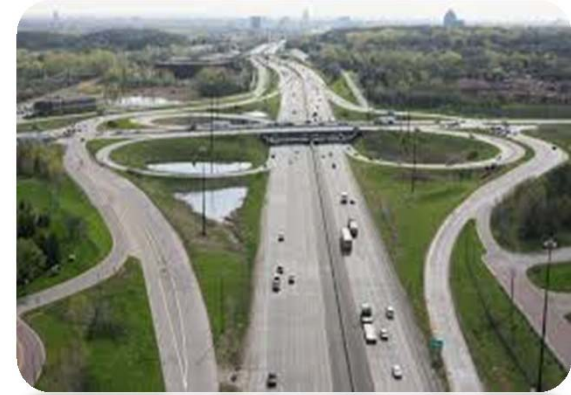
- By overlaying the pipeline onto the aerial photography, we can identify critical areas such as schools, hospitals, and major road interchanges where catastrophic water main breaks can impact property, life, and safety.
